WEATHERTIGHTNESS TESTING A  
SAMPLE OF AVON DRYWALL BEAM  
CLADDING

N950/04/13431  
11 MAY, 2004

This report describes tests carried out at our premises in Leighton Buzzard at the request of Alumet Systems (UK) Ltd, Senator House, Bourne End, Kineton Road Industrial Estate, Southam, Warwickshire CV47 0NA.

The test sample consisted of a sample of Avon Drywall Beam Cladding manufactured by Alumet Systems.

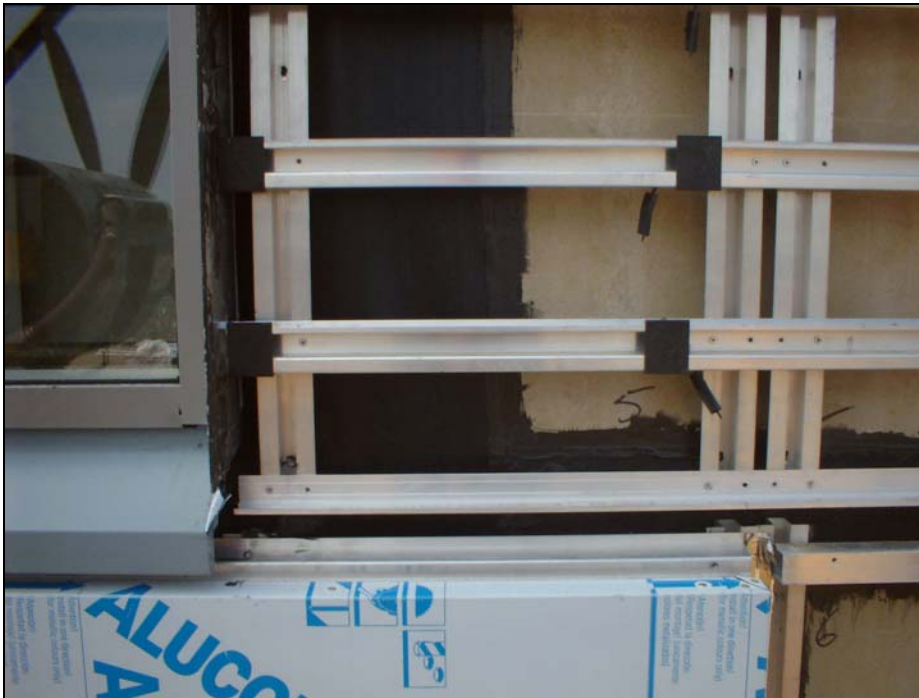
PHOTO 04130011

TERRACOTTA TILES REMOVED

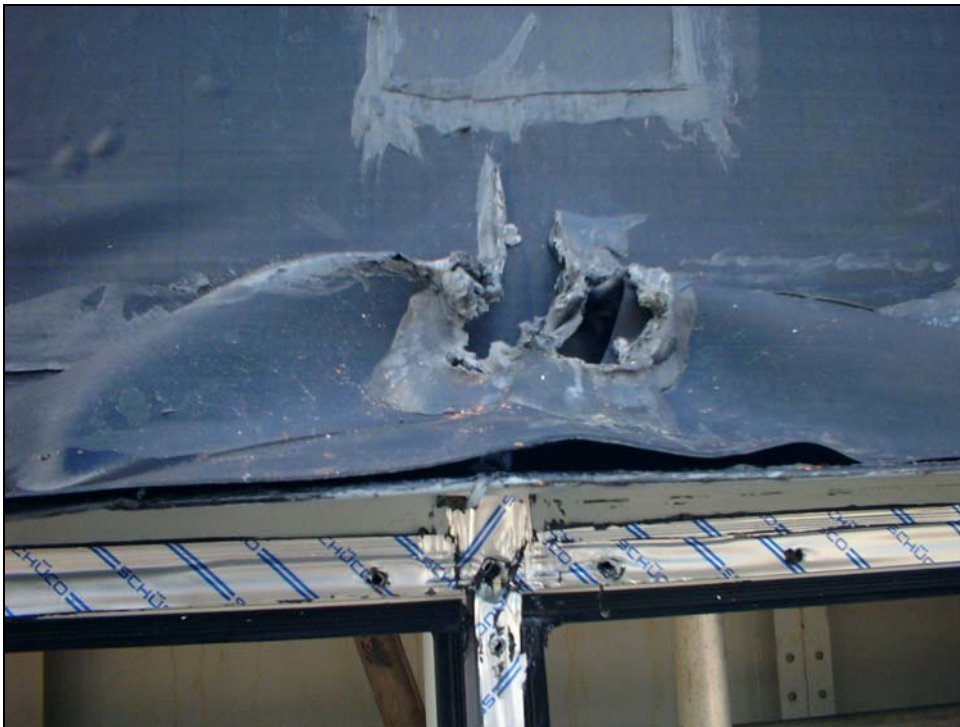
PHOTO 04130033

MENBRANE ABOVE CURTAIN WALLING

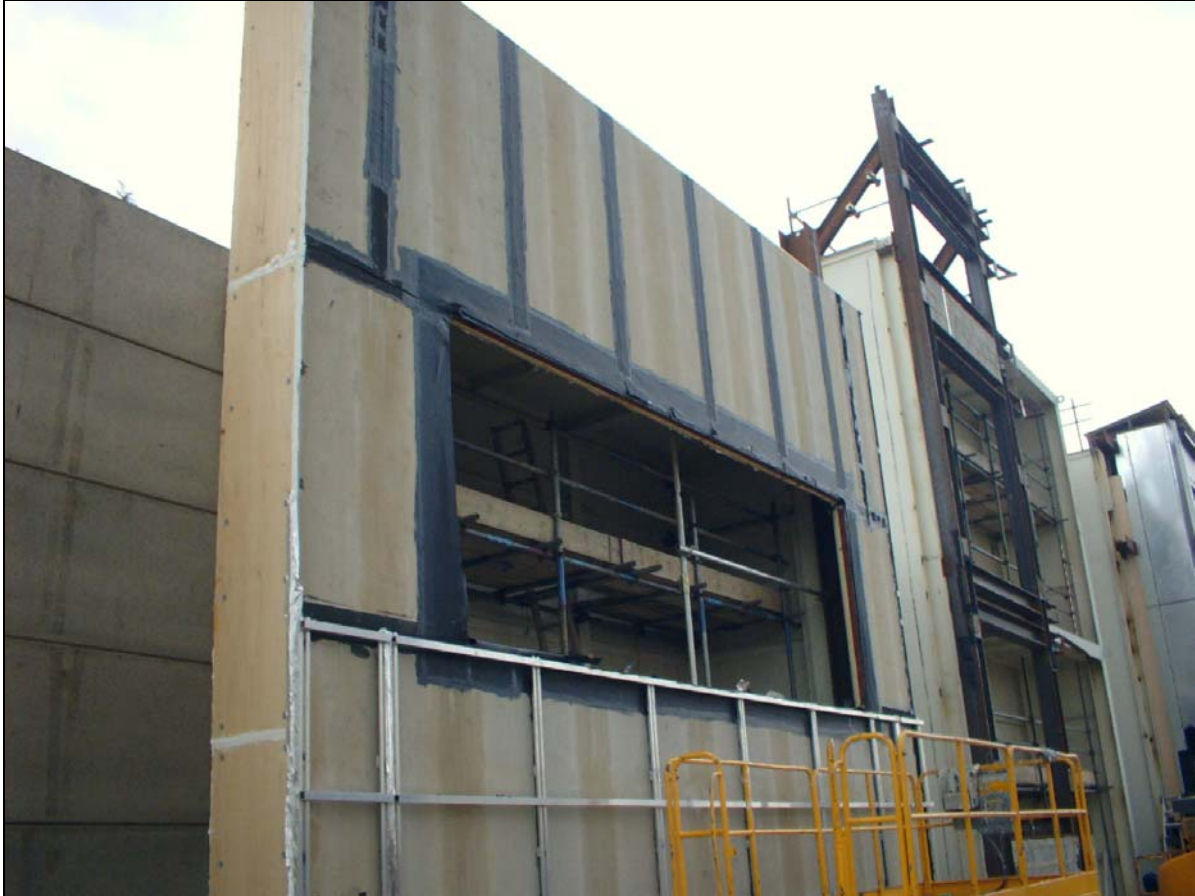
PHOTO 04130043

RAINSCREEN PANELS/TILES AND CURTAIN WALLING REMOVED.

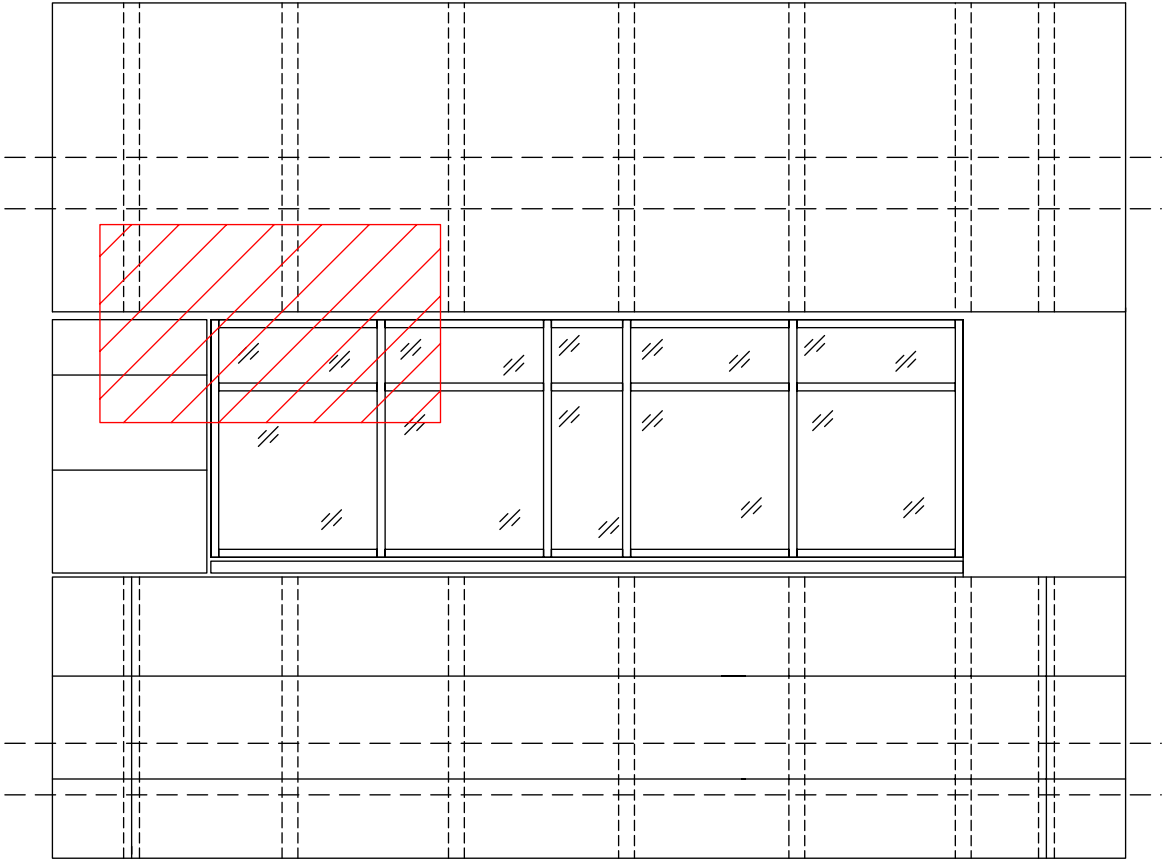
FIGURE 3

Throughout the test the interior face of the sample was examined for water penetration. The joints tested are shown in Figure 3.

No water penetration was observed throughout the test.

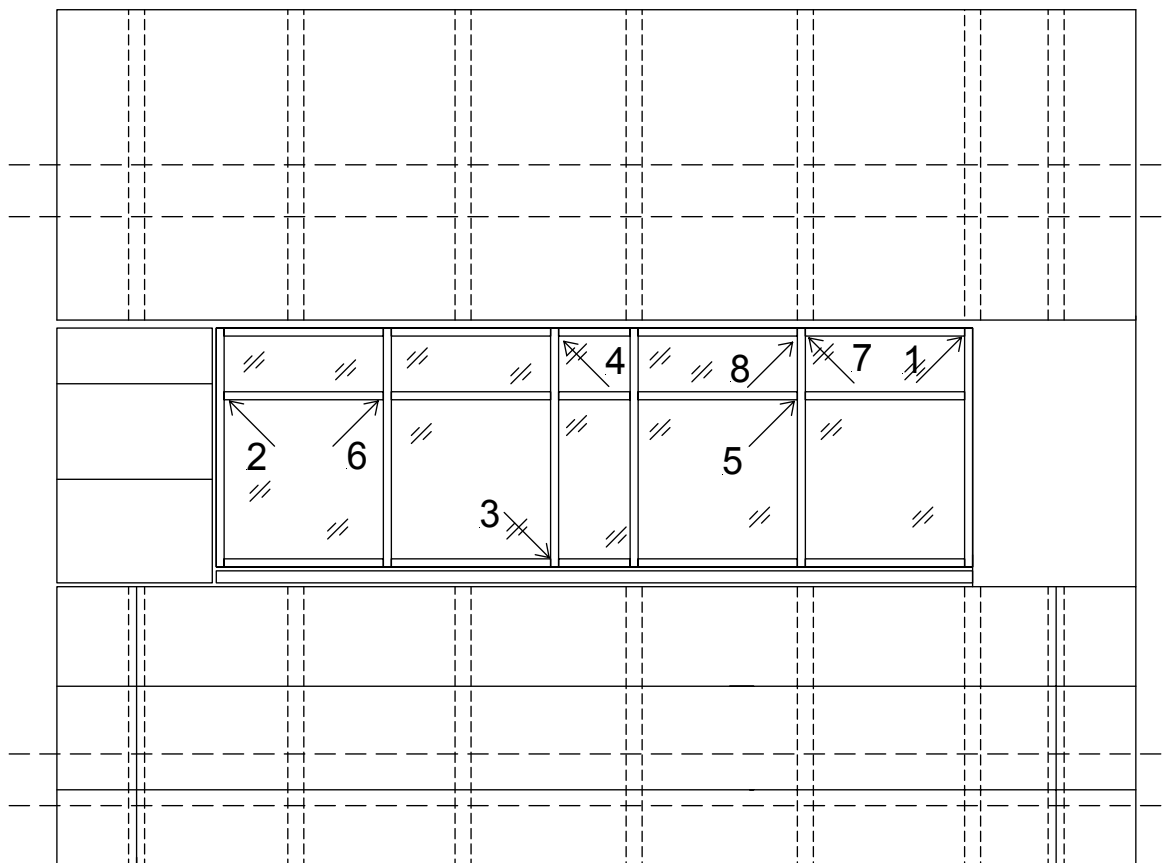
FIGURE 4

Water leakage was observed during the test as described below and shown in Figure 4.

At zero pressure water was observed from transom/mullion joints at locations 1 & 2.

At a pressure differential of 50 pascals, water was observed from transom/mullion joints at locations 3 & 4.

At a pressure differential of 100 pascals, water was observed from transom/mullion joints at locations 5 & 6.

At a pressure differential of 450 pascals, water was observed from transom/mullion joints at locations 7 & 8.

The following remedial work was carried out by Alumet Systems.

The missing EPDM was fitted to the head of the curtain walling.

The drain channel obscured by the head trim was cleared.

The pressure plate screws were torqued up to 6-7 Nm.

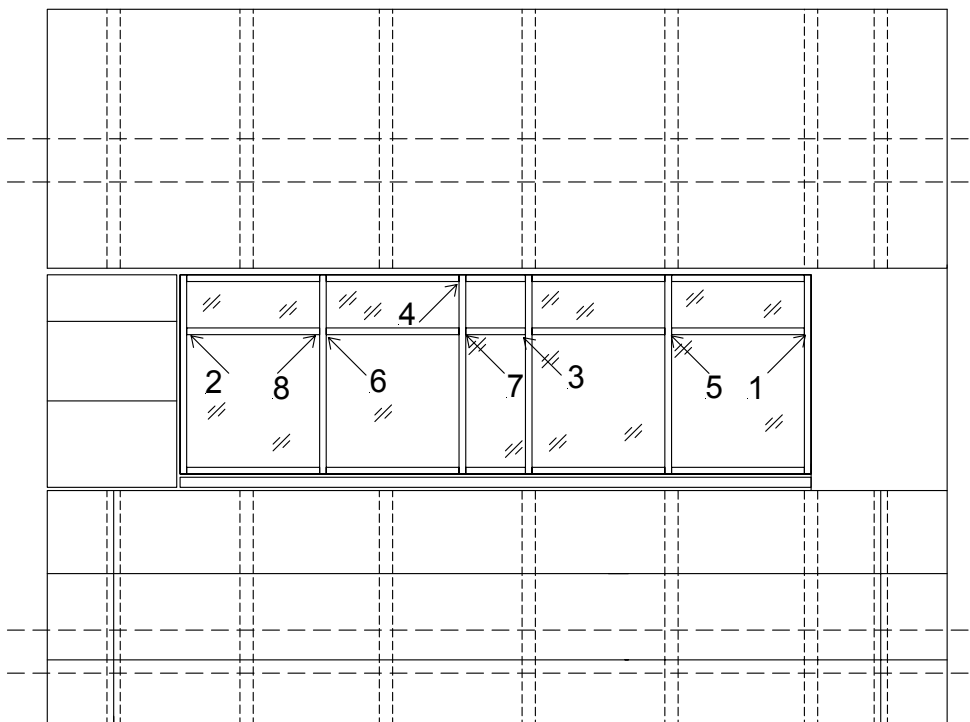
FIGURE 5

Water leakage was observed during the test as described below and shown in Figure 5.

At a pressure differential of 150 pascals, water was observed from transom/mullion joints at locations 1, 2 & 3.

At a pressure differential of 200 pascals, water was observed from transom/mullion joints at locations 4 & 5.

At a pressure differential of 450 pascals, water was observed from transom/mullion joint at location 6.

At a pressure differential of 600 pascals, water was observed from transom/mullion joints at locations 7 & 8.

The following remedial work was carried out by Alumet Systems.

The SARA curtain walling was replaced with Schuco curtain walling.

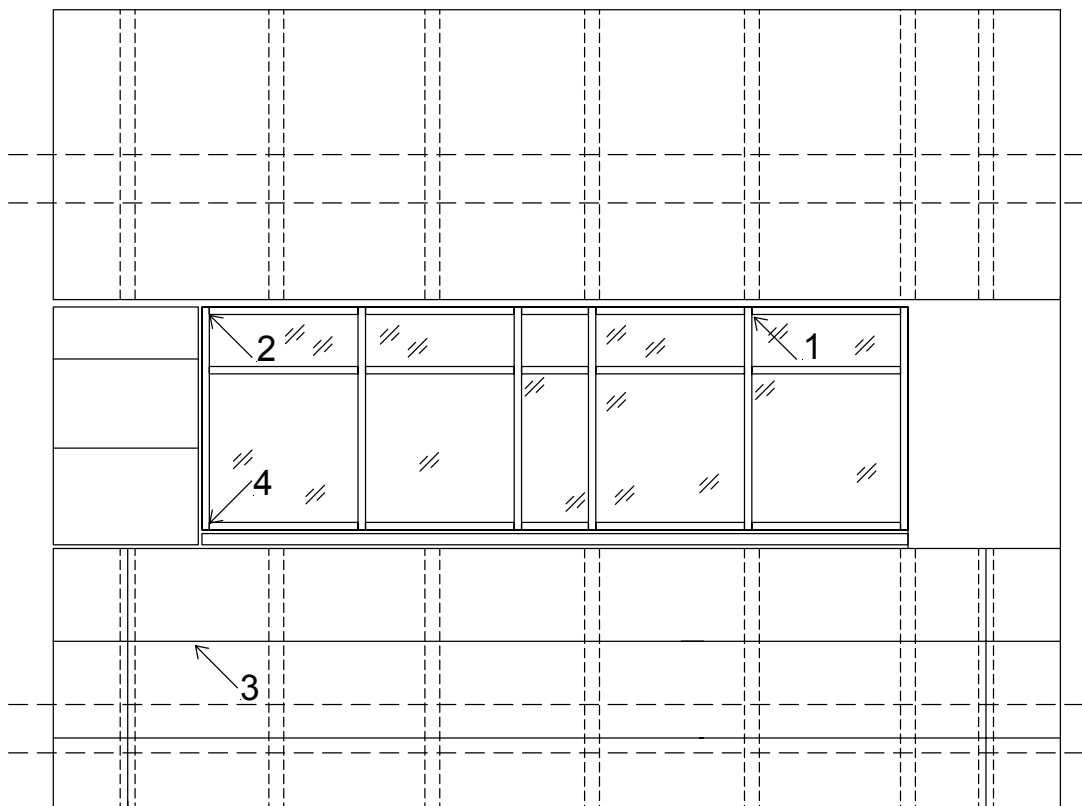
FIGURE 6

Water leakage was observed during the test as described below and shown in Figure 6.

At a pressure differential of 300 pascals, water was observed from transom/mullion joint at location 1.

At a pressure differential of 450 pascals, water was observed from transom/mullion joint at location 2.

At a pressure differential of 600 pascals, water was observed from the EPDM seal at location 3. Water was also observed from the glazing gasket at location 4.

The following remedial work was carried out by Alumet Systems.

The membranes were amended as shown in the drawings included at the back of this report.

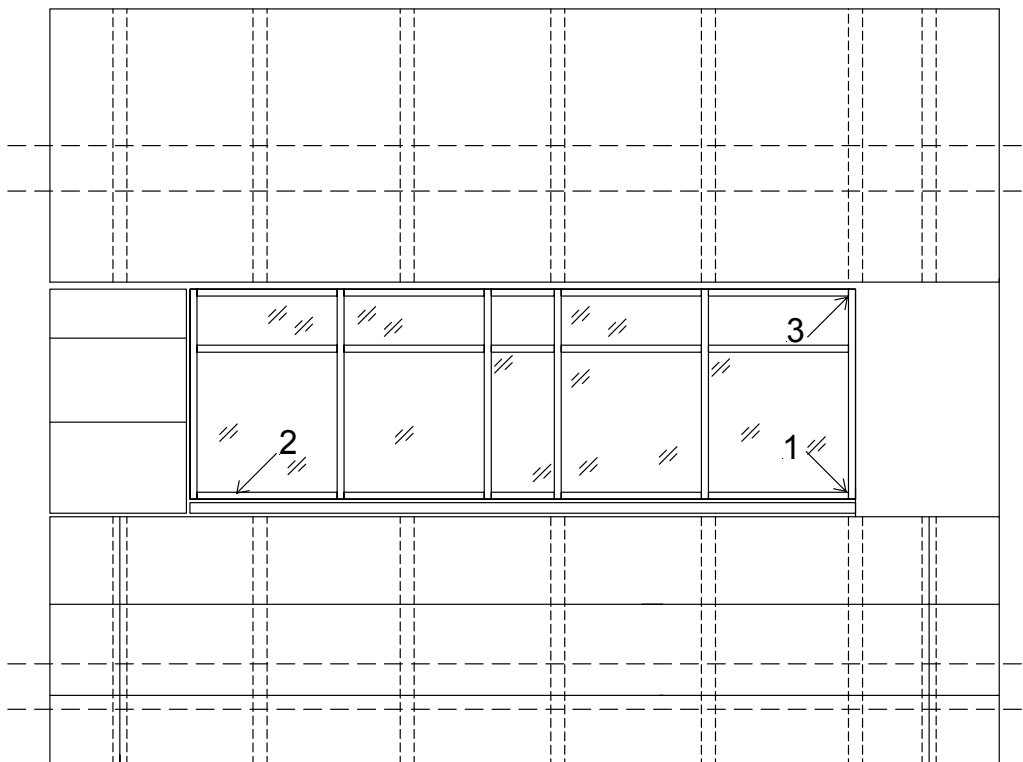
FIGURE 7

Water leakage was observed during the test as described below and shown in Figure 7.

At a pressure differential of 450 pascals, water was observed from the membrane at locations 1 & 2.

At a pressure differential of 600 pascals, water was observed from transom/mullion joint at location 3.

The following remedial work was carried out by Alumet Systems.

The EPDM carrier was re-applied at the bottom of the curtain walling.

A hole was repaired in the bottom right hand side of the membrane.

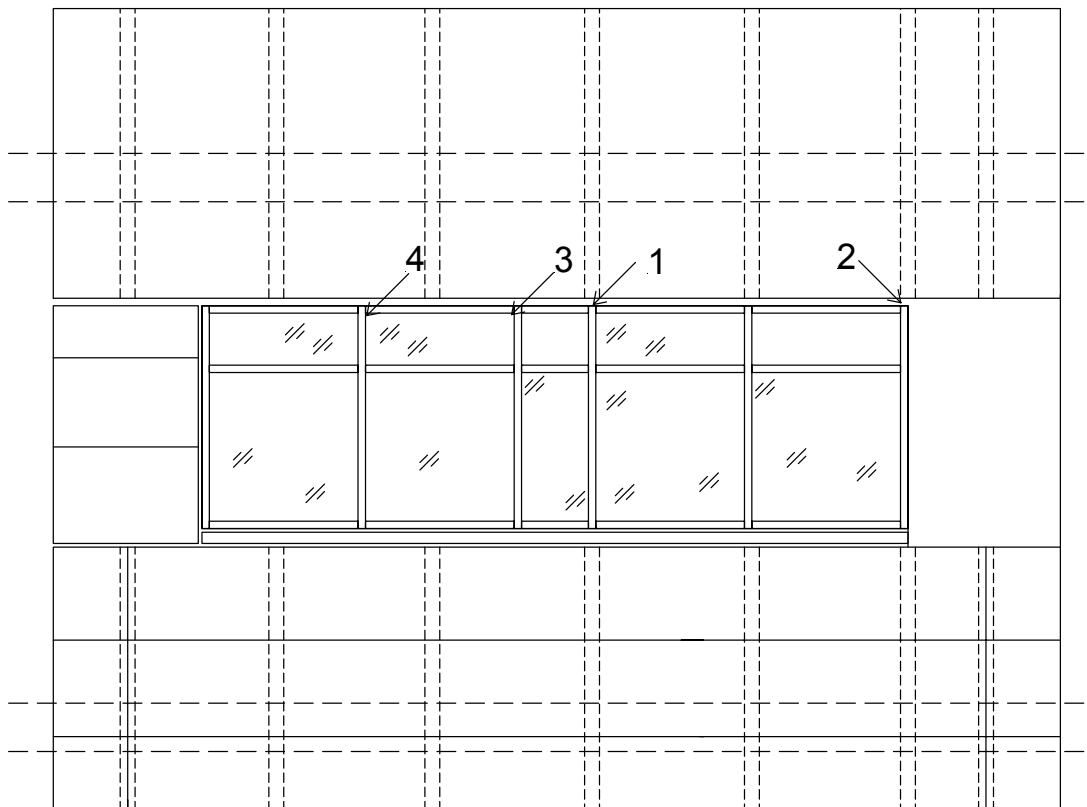
FIGURE 8

Water leakage was observed during the test as described below and shown in Figure 8.

At a pressure differential of 150 pascals, water was observed from the membrane at location 1.

At a pressure differential of 200 pascals, water was observed from the membrane at location 2.

At a pressure differential of 600 pascals, water was observed from transom/mullion joints at locations 3 & 4.

The following remedial work was carried out by Alumet Systems.

The EPDM was re-fitted to the head of the curtain walling and the internal tape re-fitted from the curtain walling to the beam.

The inner seal from between the curtain walling and beam was renewed.
