WEATHERTIGHTNESS TESTING A  
SAMPLE OF AVON DRYWALL BEAM  
CLADDING

N950/04/13431  
11 MAY, 2004

This report describes tests carried out at our premises in Leighton Buzzard at the request of Alumet Systems (UK) Ltd, Senator House, Bourne End, Kineton Road Industrial Estate, Southam, Warwickshire CV47 0NA.

The test sample consisted of a sample of Avon Drywall Beam Cladding manufactured by Alumet Systems.

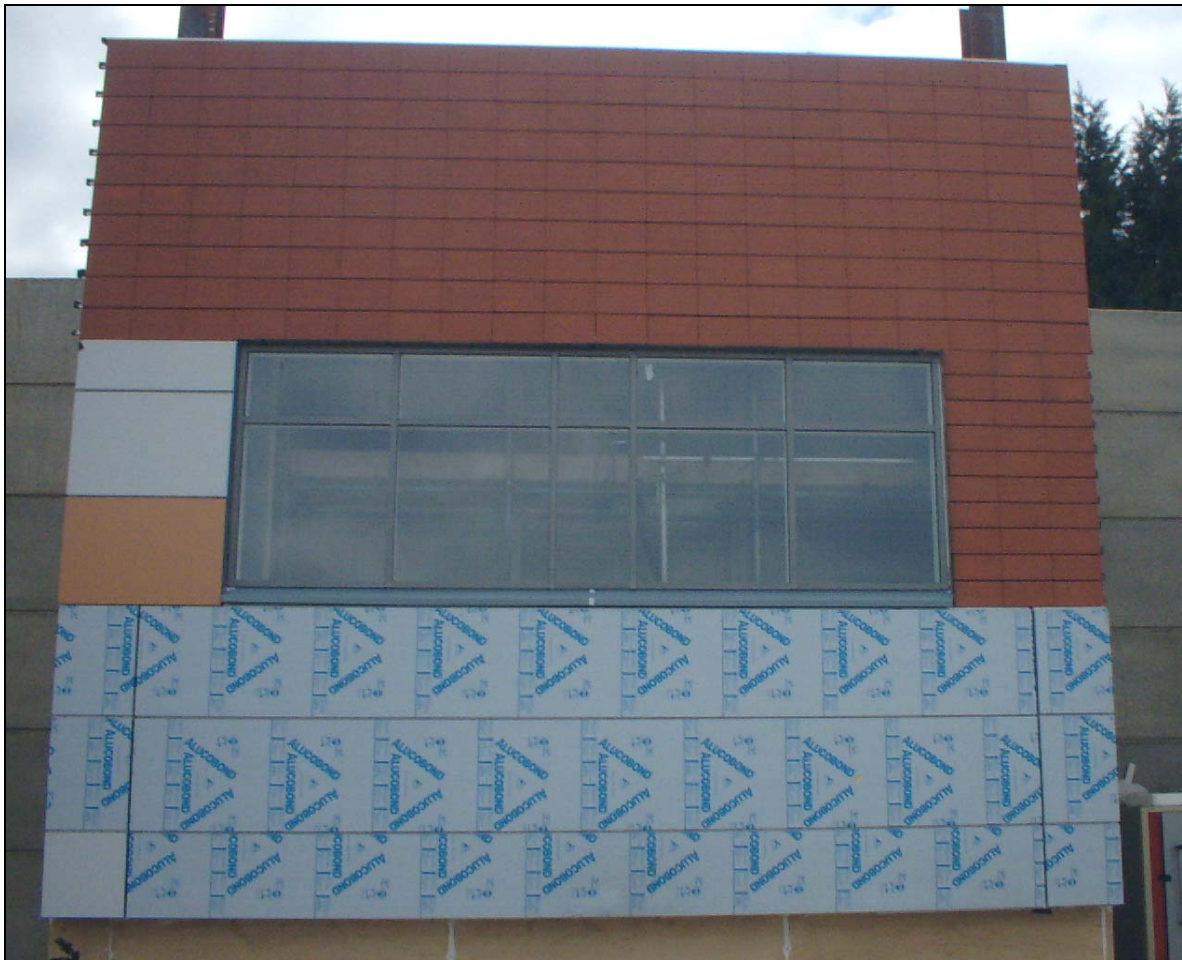
PHOTO 04070001

TEST SAMPLE ELEVATION

During the dismantling of the sample no water penetration or discrepancies from the drawings were found.
